**EASTBOUND STATE ROUTE 56 (SR-56)**  
**BIKE PATH FENCE COLLISION SUMMARY**

**FROM**  
**CARMEL VALLEY ROAD**  
**TO**  
**RANCHO PENASQUITOS BOULEVARD**  
**(PM 3.1 - PM 8.0)**

**(2008 -2011)**

**Date Prepared**  
**Sept. 2011**

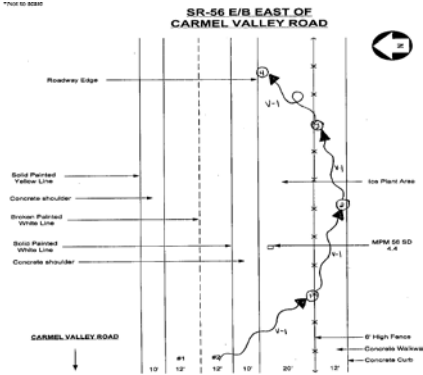
### Traffic Collision #1

PM          DATE          COLLISION TIME  
3.38        6/21/2008        0210

Party #1 was driving Vehicle #1 (V-1, Ford Ranger), while under the influence of an alcoholic beverage, on SR-56 eastbound, west of the Caramel Valley overcrossing in an unknown lane at an unknown speed. Due to P-1's level of intoxication, coupled with his unsafe turning movement, the right-front of V-1 collided with the fence line, south of SR-56. V-1 continued through the fence and collided with the concrete curb, south of a walkway, south of SR-56. P-1 then made an abrupt turning movement to the left, and V-1 collided with the fence line again, south of SR-56. V-1 continued through the fence line and overturned in the ice plant, south of SR-56. V-1 came to rest on its left side facing in a south-easterly direction partially in the #2 lane and partially on the right shoulder of SR-56 eastbound.

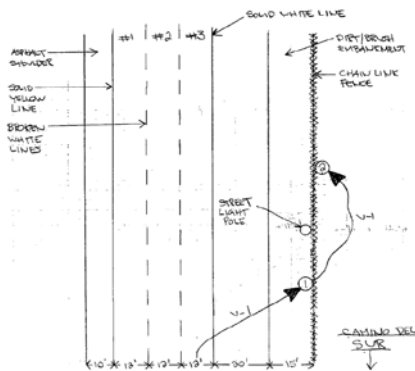
### Traffic Collision # 2

PM          DATE          COLLISION TIME  
6.22        11/14/2009        2340

Party #1 (P-1) was driving Vehicle #1 (V-1) (Honda) on SR-56 e/b east of Camino Del Sur in the #3 lane at 65 mph. Due to P-1's sleepy/fatigued condition, P-1 made an unsafe turning movement to the right. V-1 veered to the right up the dirt/brush embankment where the front of V-1 collided with the chain link fence at the top of the embankment. V-1 continued through the chain link fence. P-1 turned V-1 left and veered to the left where the front of V-1 collided with the chain link fence. Following the collision V-1 came to rest on it wheels with the front resting against the chain link fence, facing in a northwesterly direction on the dirt/brush embankment south of SR-56 e/b.

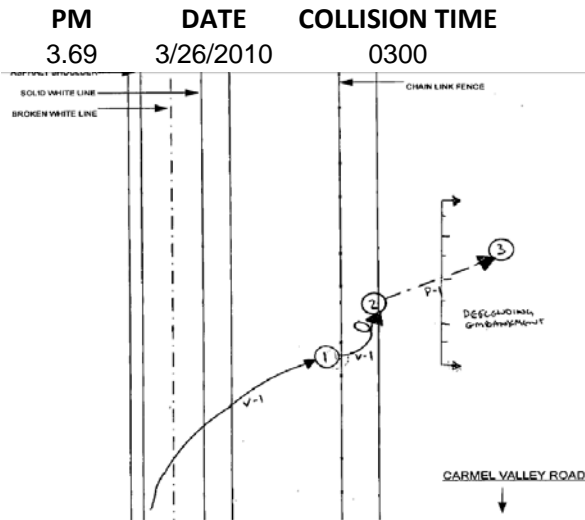
### Traffic Collision # 3

Party #1 (P-1) drove Vehicle #1 (V-1, Ford) in an intoxicated state on SR-56 eastbound, east of Carmel Valley Road in the #1 lane at approximately 75 MPH. Due to P-1's intoxication, P-1 drifted to the left shoulder and then turned V-1 to the right, causing V-1 to cross over the #2 lane and right shoulder. V-1 continued off the roadway, driving on the ice plant off the south road edge of SR-56. V-1 struck the chain link fence at the north edge of the bike/walking path that runs parallel to SR-56 eastbound. As V-1 struck the chain link fence, P-1 turned V-1 to the left, causing V-1 to overturn and strike the asphalt bike/walking path with its roof. P-1 was unsecured and was ejected from V-1 as it overturned. P-1 struck the descending dirt embankment south of south edge of the bike/walking path, and came to rest on the embankment. V-1 then rolled onto its wheels and came to rest facing a northerly direction on the south edge of the bike/walking path.
